Post-Bushfire erosion - Tumbarumba

The Upper Murray is the headwaters of the Murray, upstream of the Hume Weir on the NSW side. This site is in the Munderoo Ck Catchment, near Tumbarumba

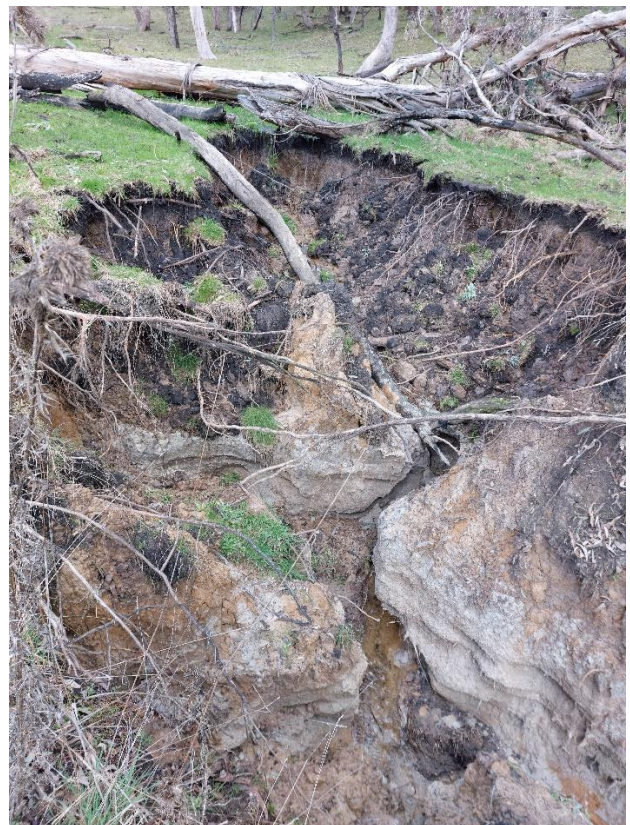
The unnamed tributary had a major headcut that was reactivated after being impacted by the 2020 Black summer Bushfires and the landholder's attempt to create access across the deepening creek was unsuccessful.

Figure 1. One of several active headcuts.

The major headcut is working into an intact valley fill feature in the upper reaches. This landscape feature has highly dispersive soil and subsurface trickle flows, so there was no engineering solution for the headcut.

Instead, Soil Conservation Service installed multiple instream structures using timber recovered from the fire impacted area and rock to create instream bed and sediment control and ensure access for the landholder.

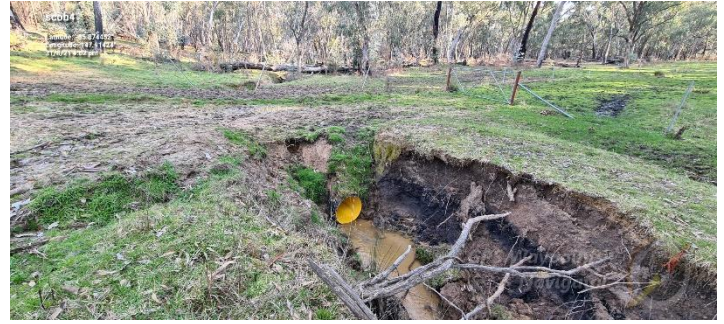
Figure 2. Post fire, the deepening of the creek meant that access to the half the property was cut off. Previous crossing attempts had multiple failures and caused large amounts of sediment to move down stream

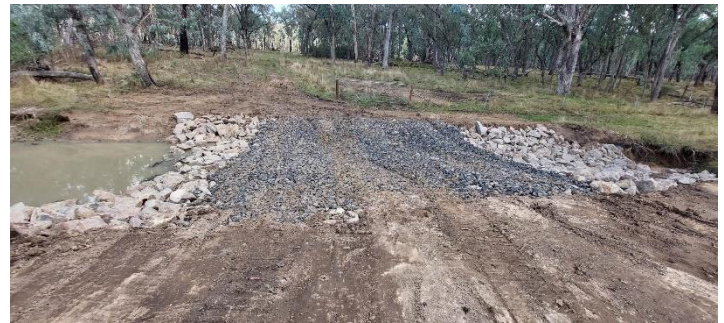
Figure 3 – this structure has a double benefit of being a grade control (slowing flow and trapping sediment above) and providing stable, long lasting access across the creek.
