Managing Upper Murray Creeks and Woodlands

Maintaining an intact Chain of Ponds

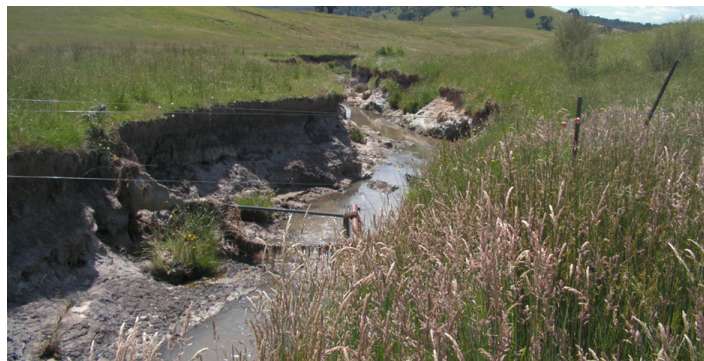
Above is a similar type of creek but a lot more degraded - the stream has eroded and left an incised (deep) channel.

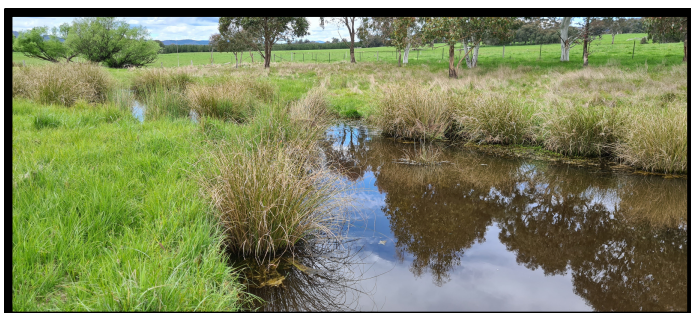
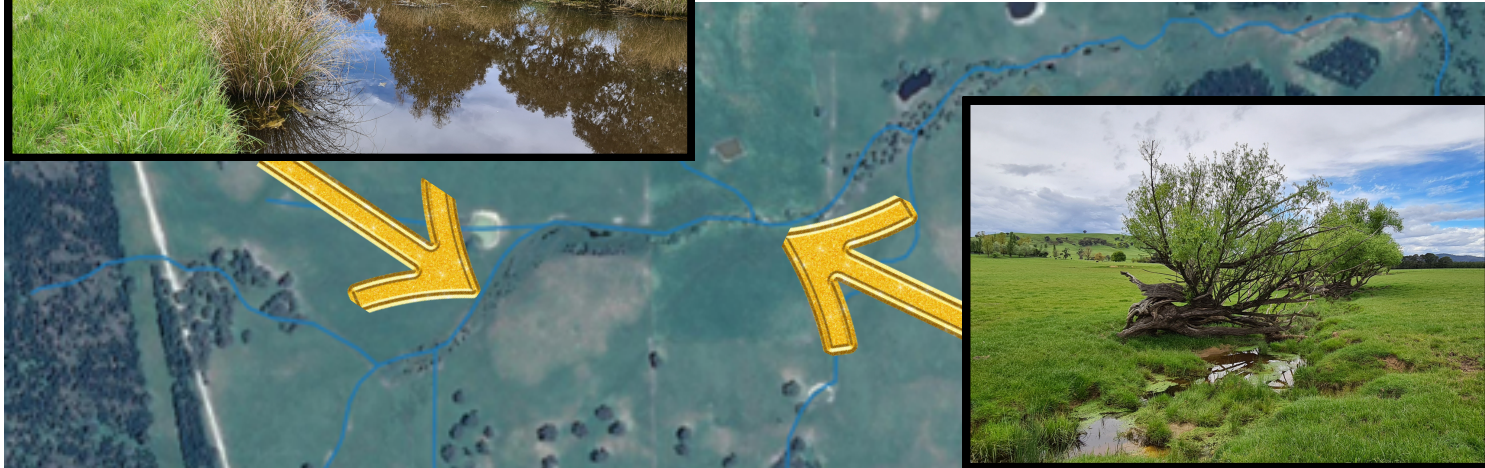
Below shows a creek in the Mannus catchment that represents what the unfenced creek looks like (on the right). The streambed has not eroded very badly but we can see willows have been planted at some stage, indicating that there was possibly worse erosion in the past. The banks are well vegetated with pasture grasses (this picture is in Spring), but all native vegetation has been cleared and there is not much in-stream vegetation either. On the left is the recovered chain-of-ponds section.

Landholders fenced and revegetated sections of this creek in the early 2000's and the difference is remarkable. No structural works were done because the stream bed was still intact (not 'incised' or eroded very deep) and could still recover. Today, these sections have retained and in some cases gone back to the chain-of-ponds structure with deep pools and swampy areas filled with a diversity of sedges and rushes.

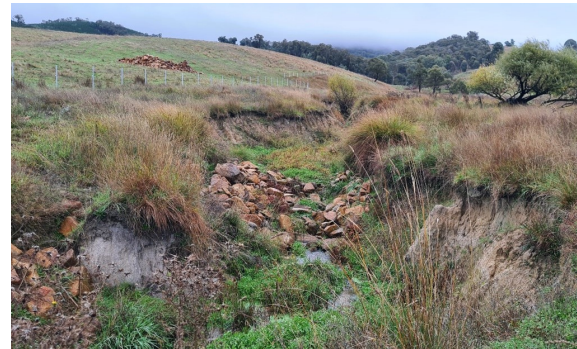
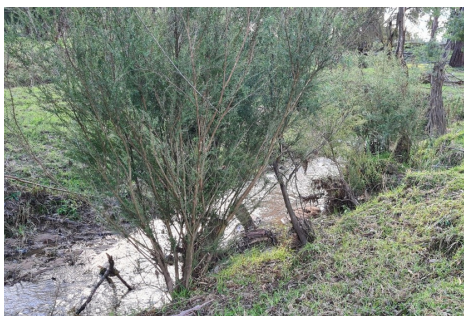
On larger creeks, bed control structures with rocks or logs may be required, but this requires professional design and permits for installation. The larger the catchment, the higher the risk of failure and a risk to the downstream water users .
